Concerning: Your new home address

By, Randall C. Wooten Professional TREC # 8726

Date: Wednesday, January 29, 2020

REPAIR SUMMARY

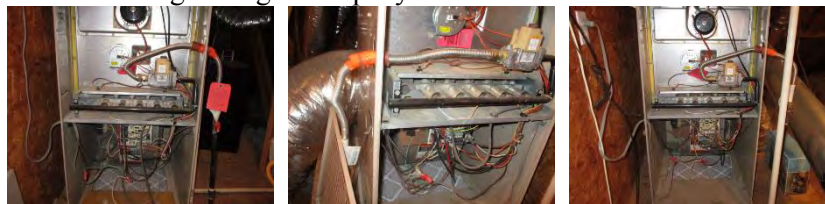
- Attic: The flexible gas lines are not allowed by current industry standards to pass into a metal cabinet of a gas heating unit due to vibration from the unit can rub a hole in the gas line. Rigid metal pipe should extend outside cabinet a minimum of 2 inches. System near media room, currently has a red tag from gas company.
